FY04 Forest Service Aviation Accident Review

NTSB Identification: **SEA04LA029.**

NTSB Identification: FTW04TA075.

NTSB Identification: SEA04TA147.

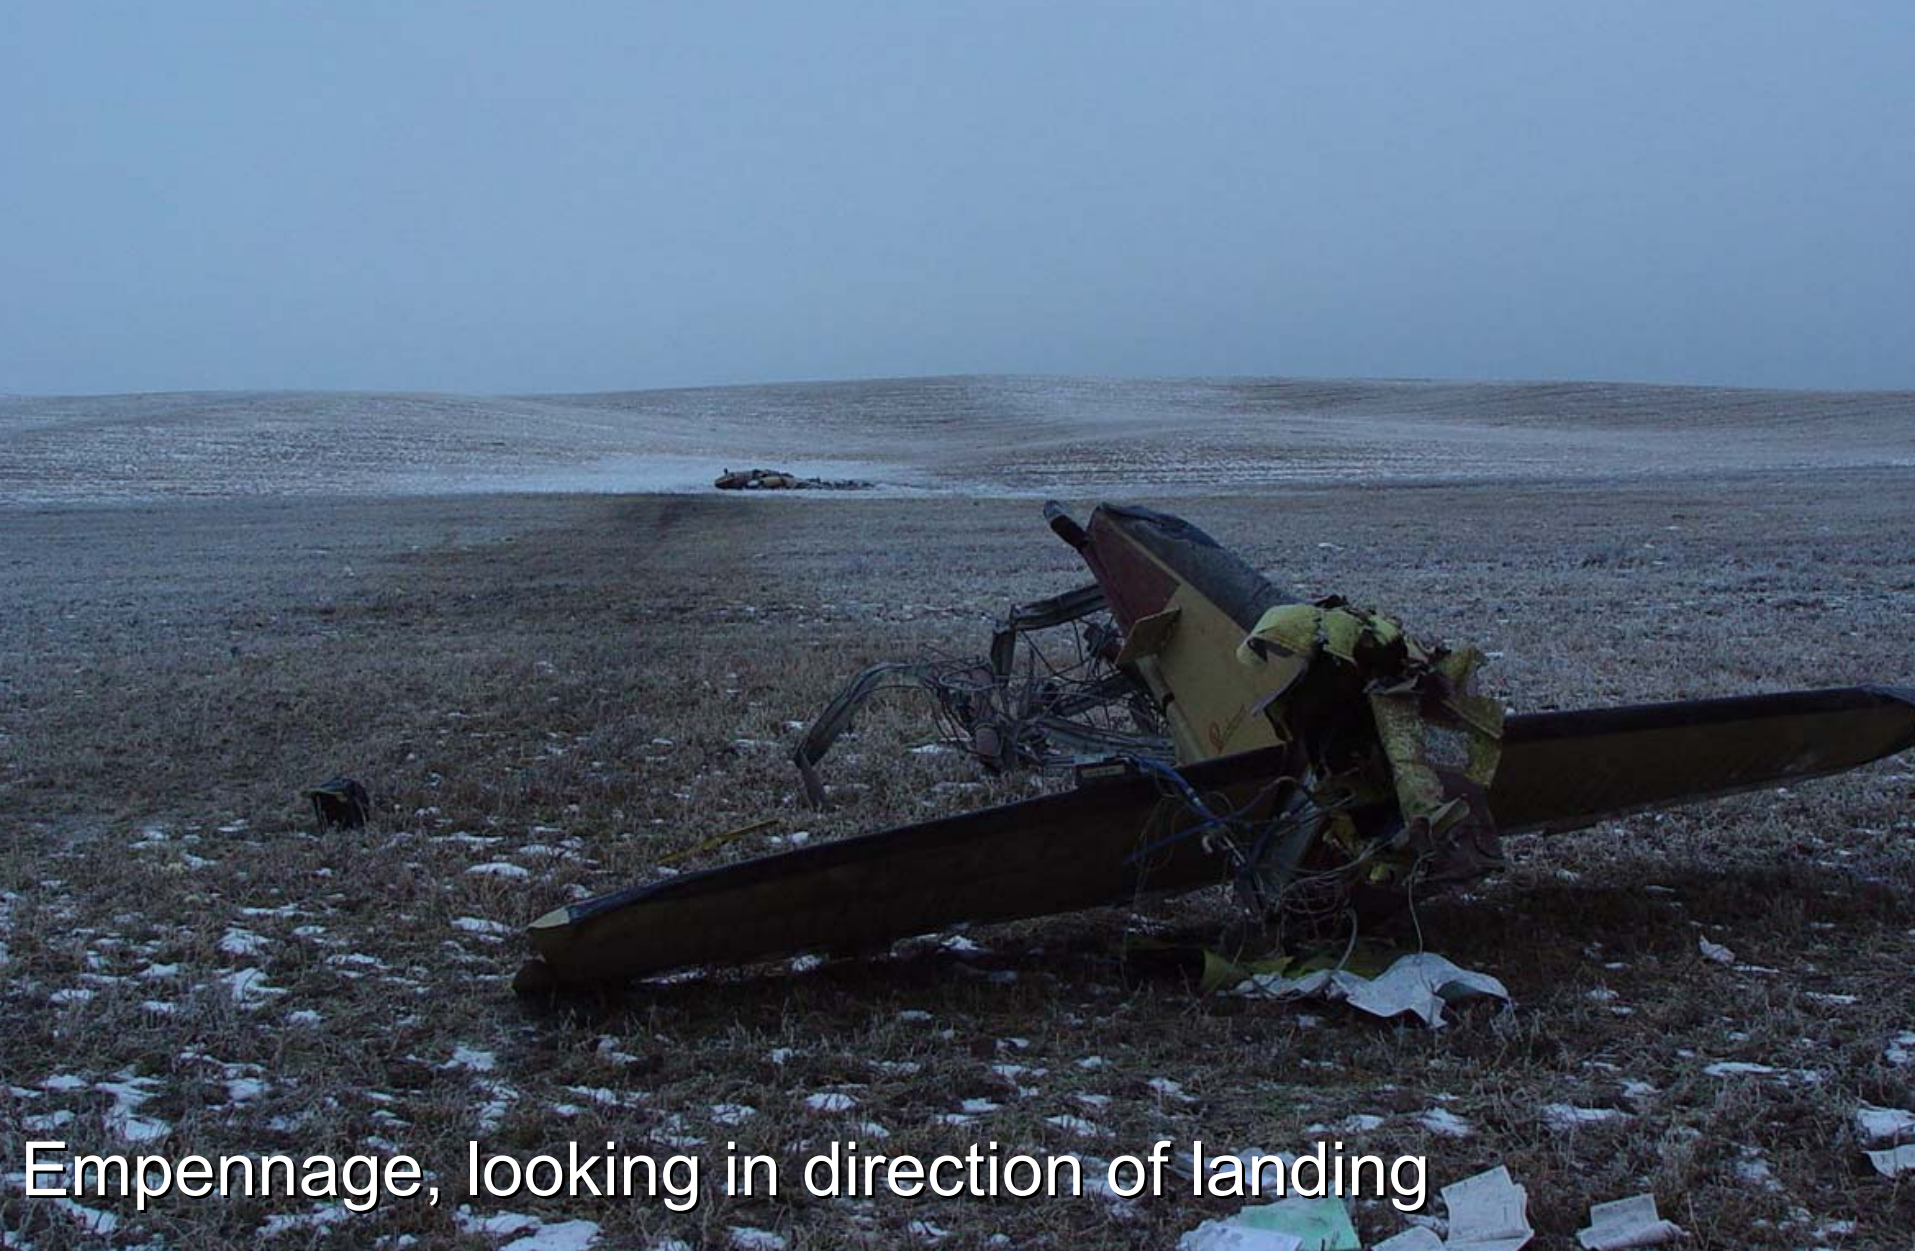
Empennage, looking in direction of landing

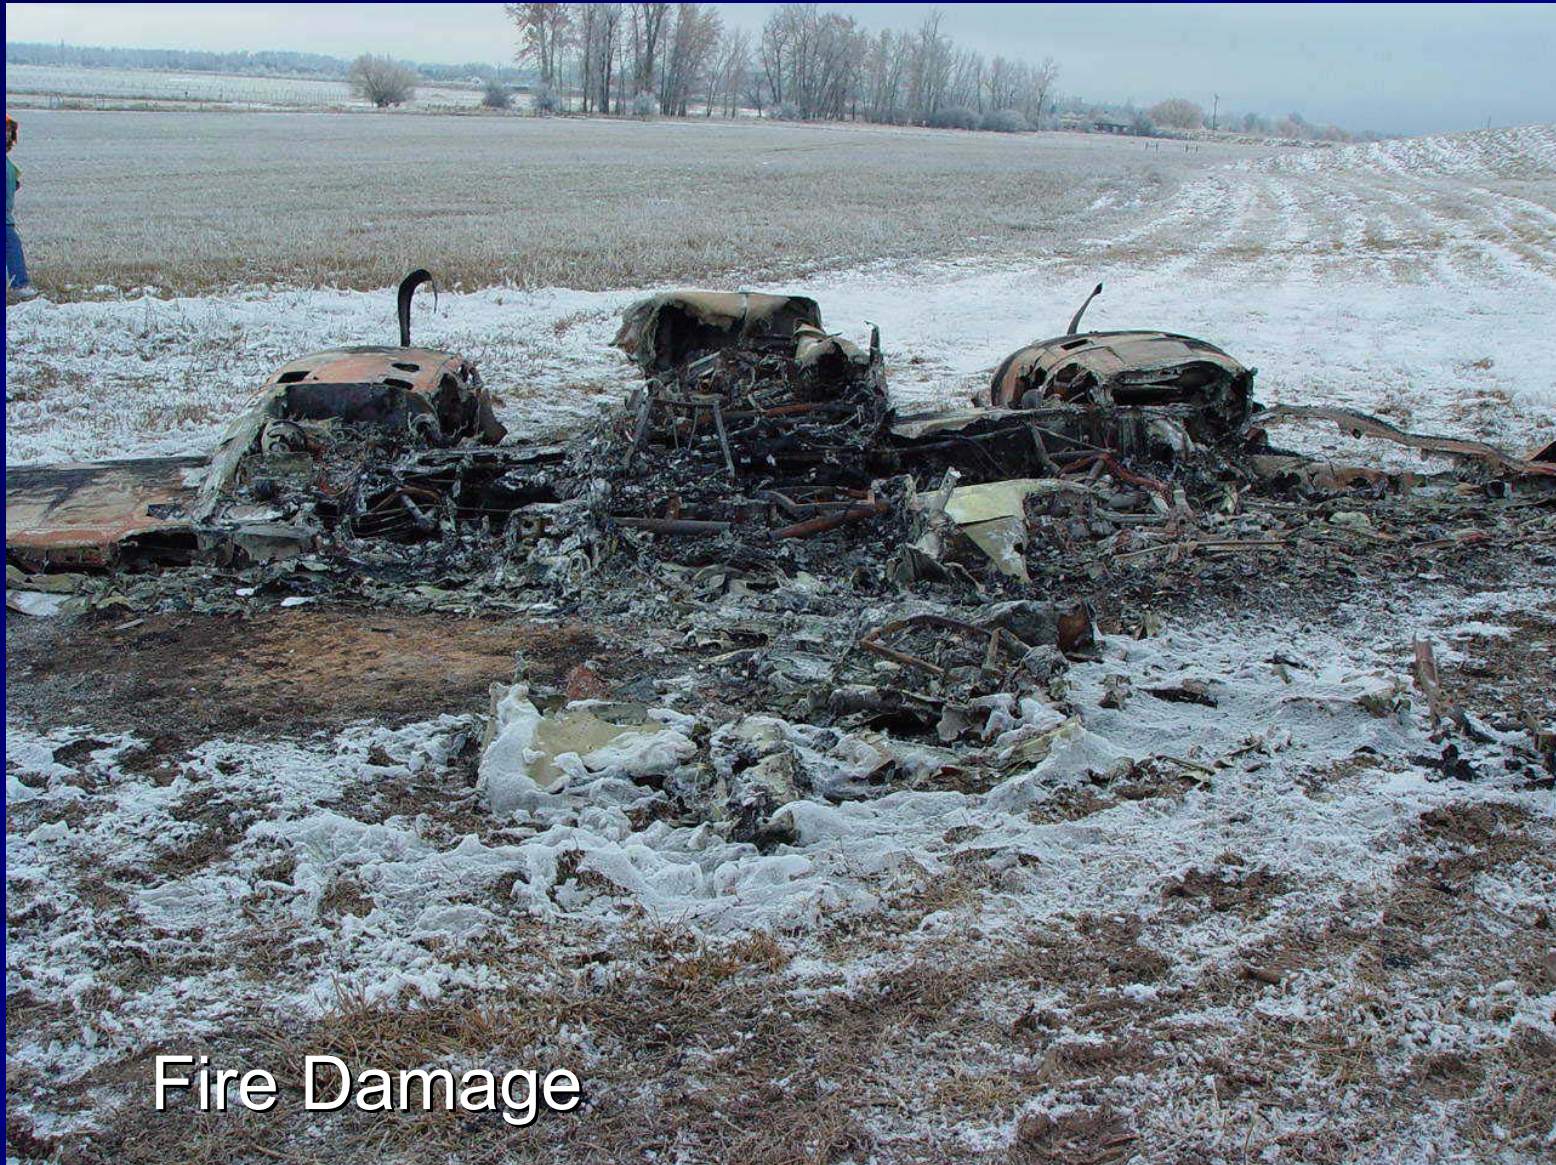
Fire Damage

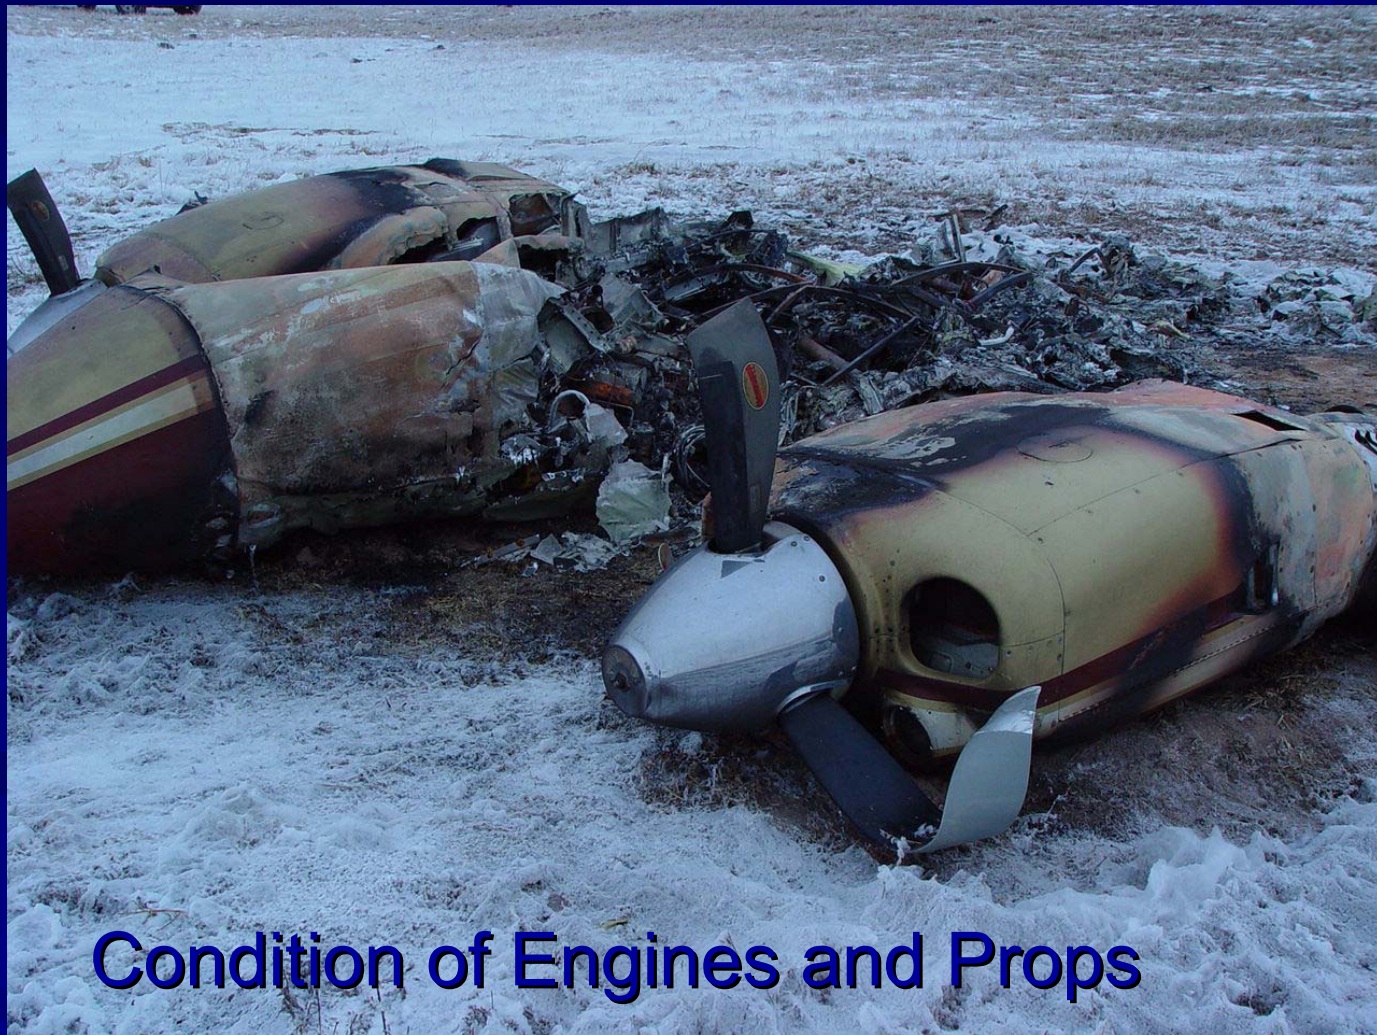
Condition of Engines and Props

During the post accident inspection of the aircraft, no evidence of a mechanical failure or malfunction was found and no evidence of an in flight collision with an object was noted. At the time of the accident, low freezing fog and visibility was reported.

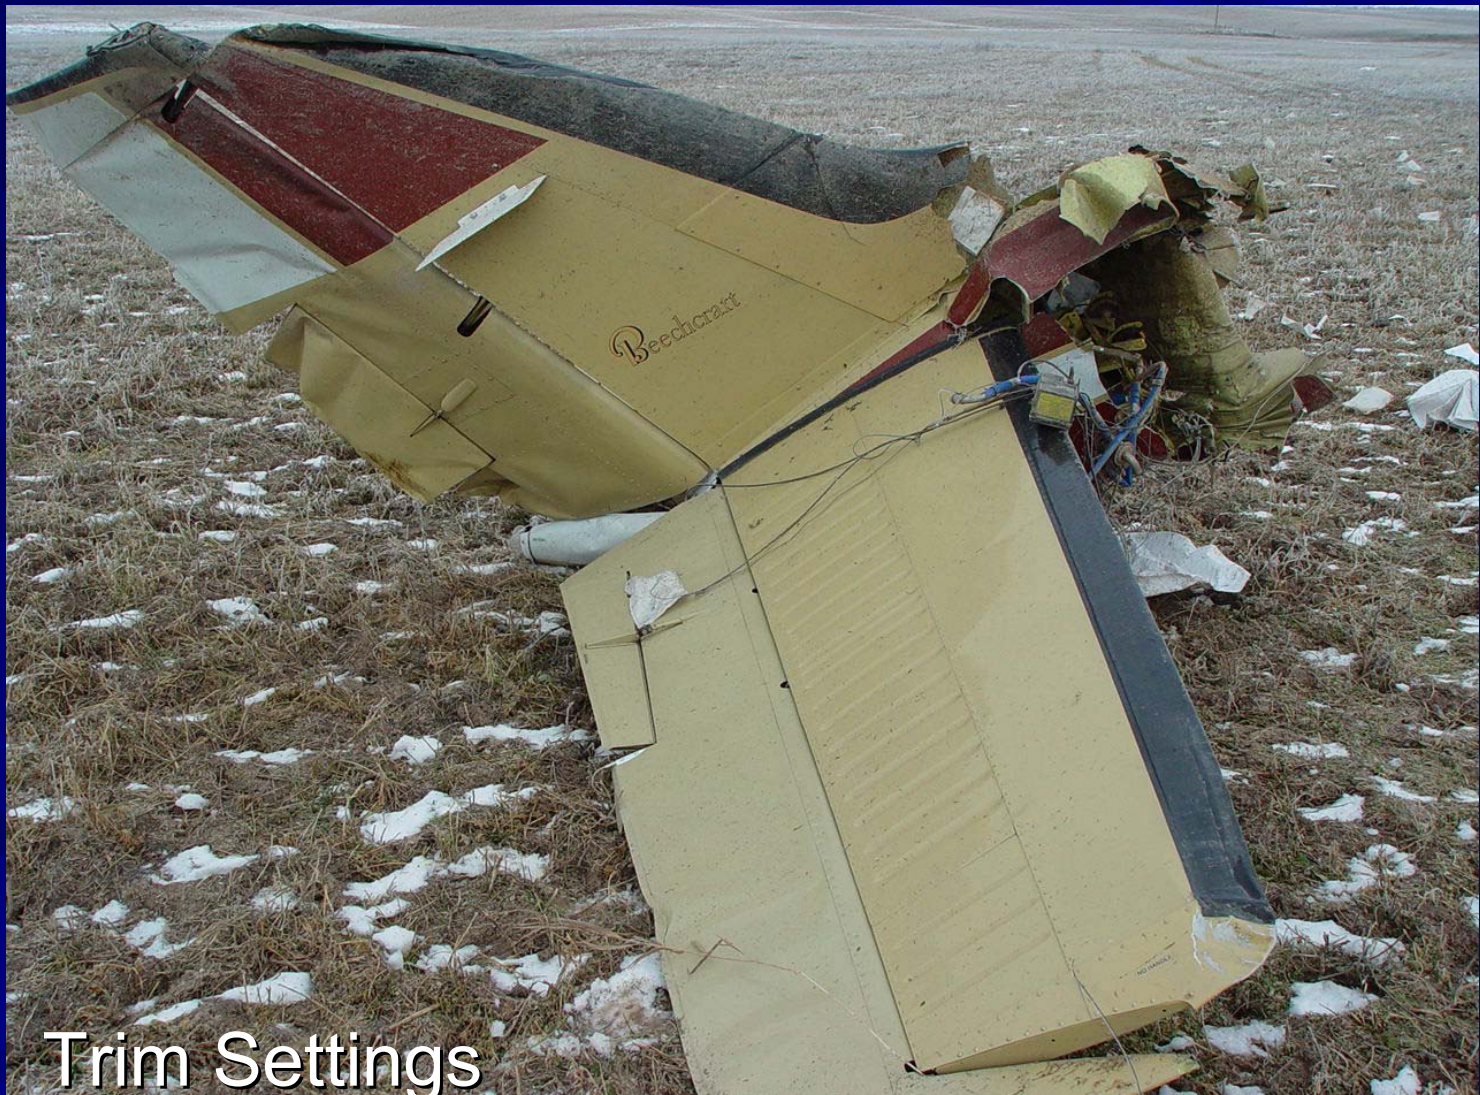
Trim Settings

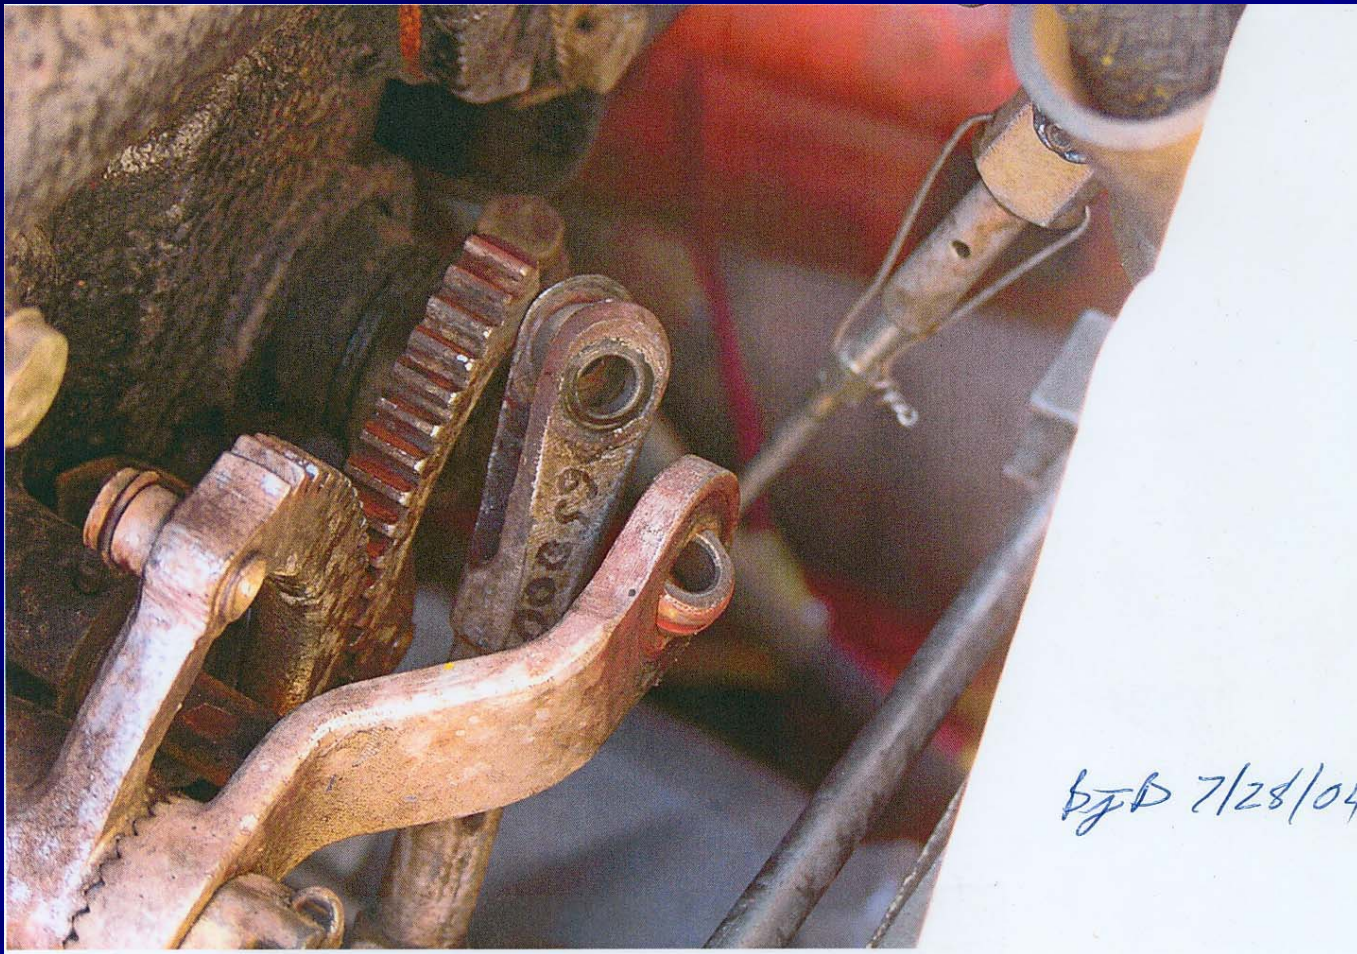
Post accident examination revealed that the bolt normally connecting the throttle linkage clevis to the throttle arm was missing. The investigating team examined a sister aircraft from the same provider. They found that a nylon lock nut had been installed on the clevis bolt, and it was loose enough to be removed without the aid of any tools.

The industry standard, found in FAA Advisory Circular AC43.13-1B, chapter 7, section 4, paragraph 7-64 states that nylon locking nuts should not be used with rotating components or assemblies. It further states that nylon and/or fiber nuts are highly susceptible to wear from repetitive use and from high heat applications.

- Review the Single Engine Airtanker (SEAT) Program
- Increase the emphasis on the SEAT maintenance program

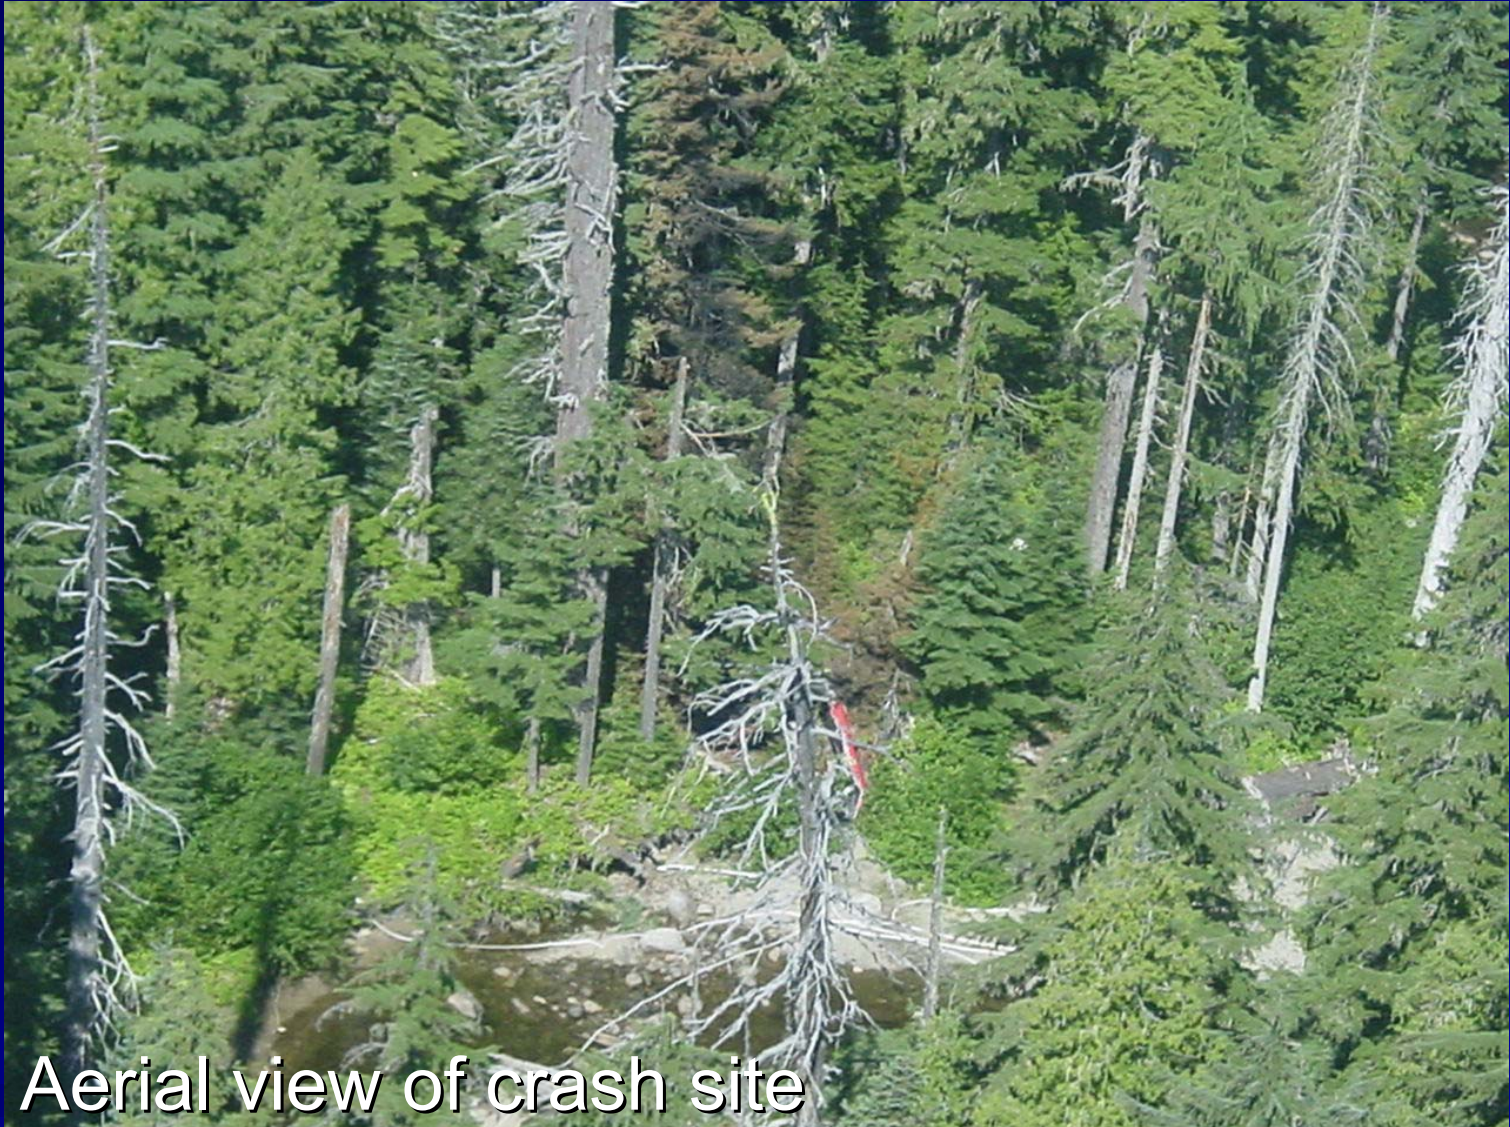
Aerial view of crash site

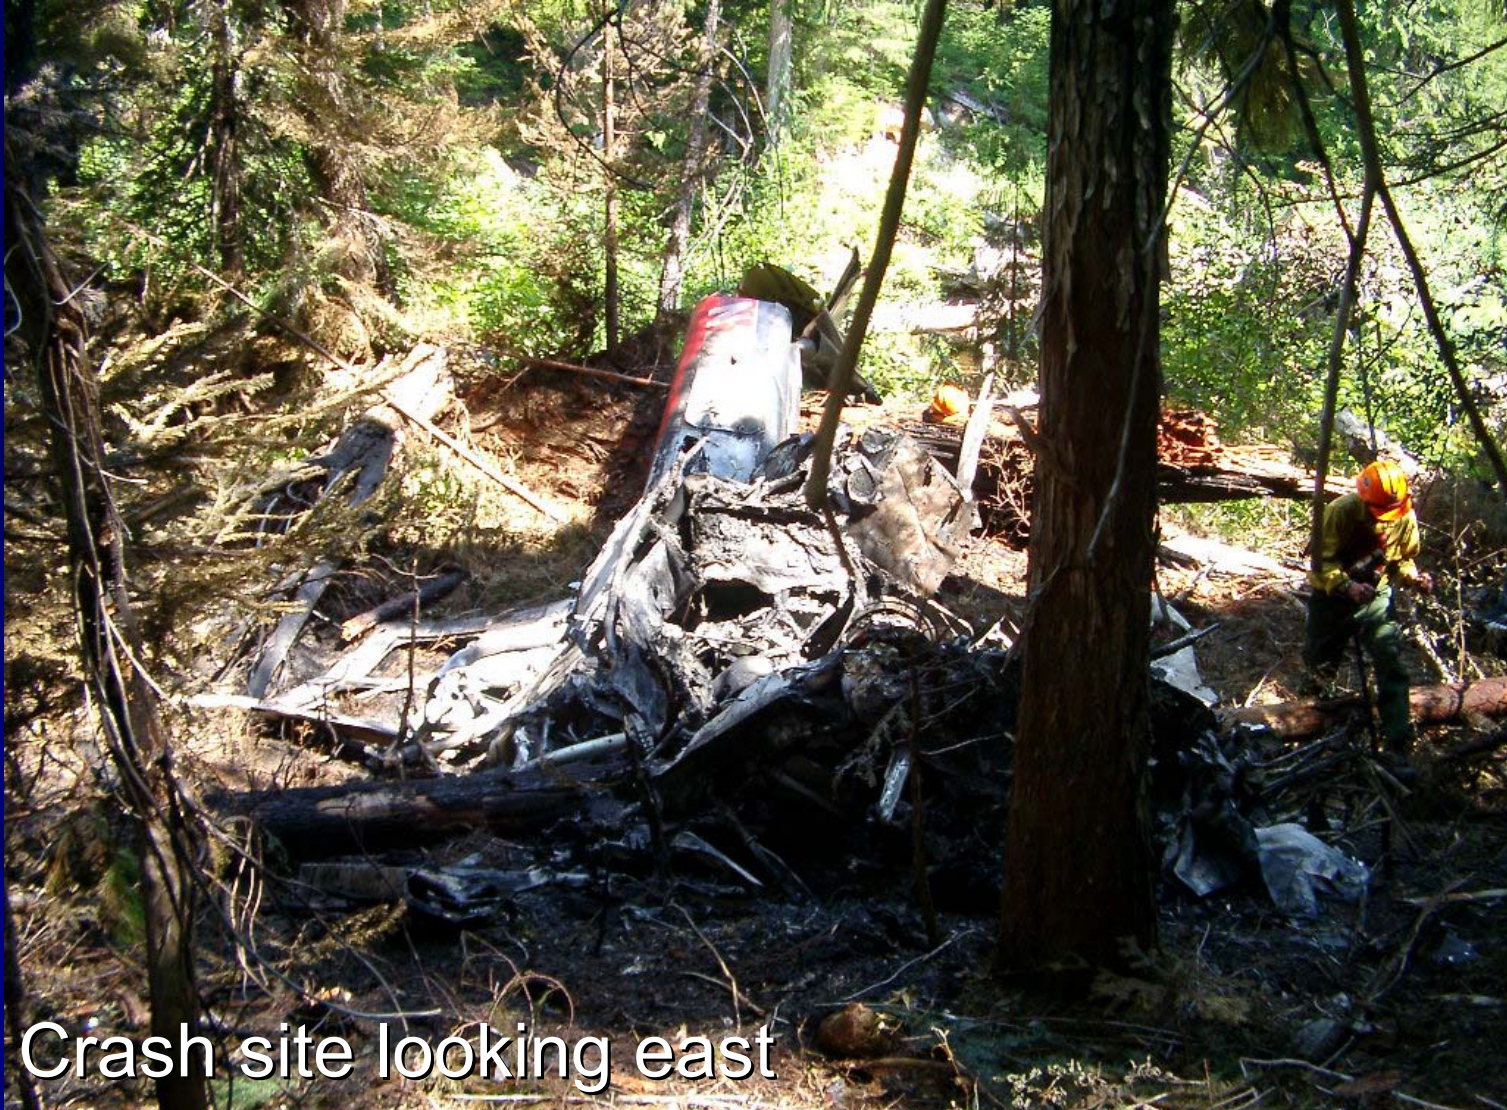
Crash site looking east

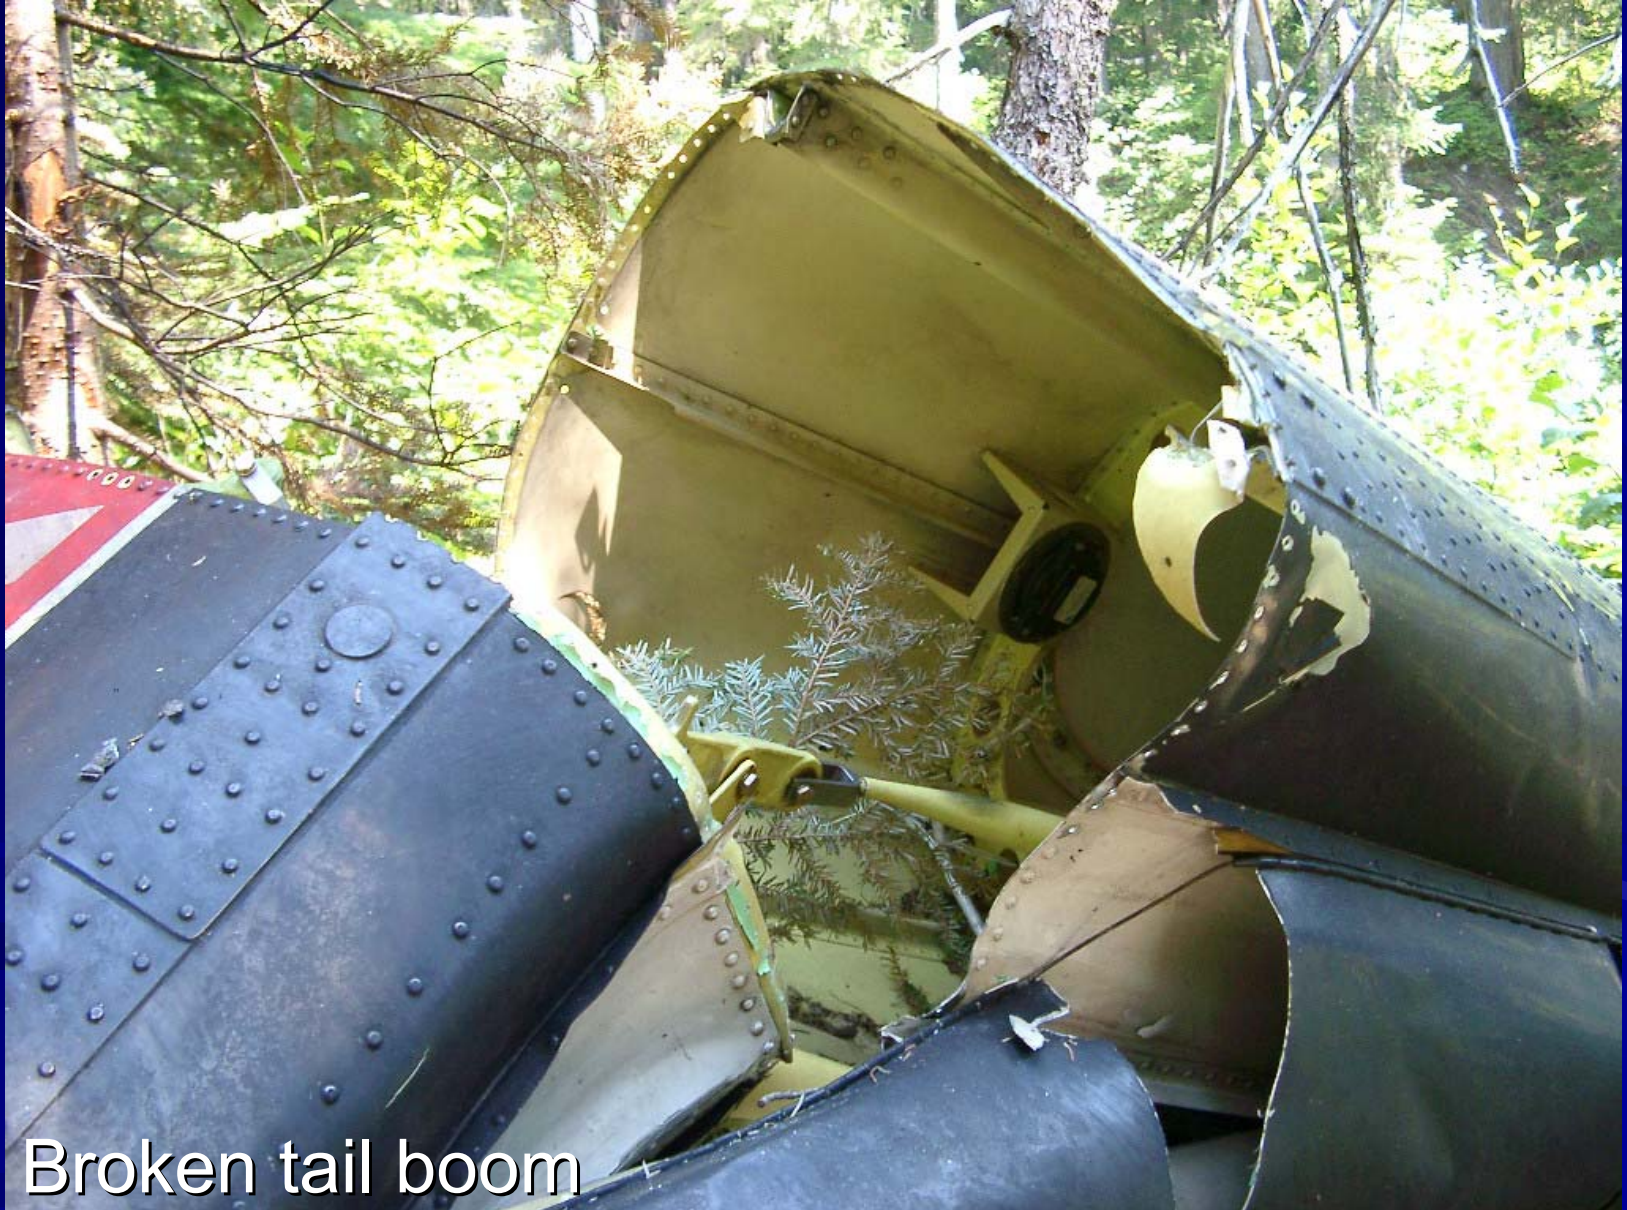
Broken tail boom

- Incorporate tree height estimation training in all longline operations training (triangulation or use of clinometers).
- Adopt landing zone rotor clearance standards in the Interagency Helicopter Operations Guide (IHOG) for longline operations where aircraft must descend below any obstacles/barriers.

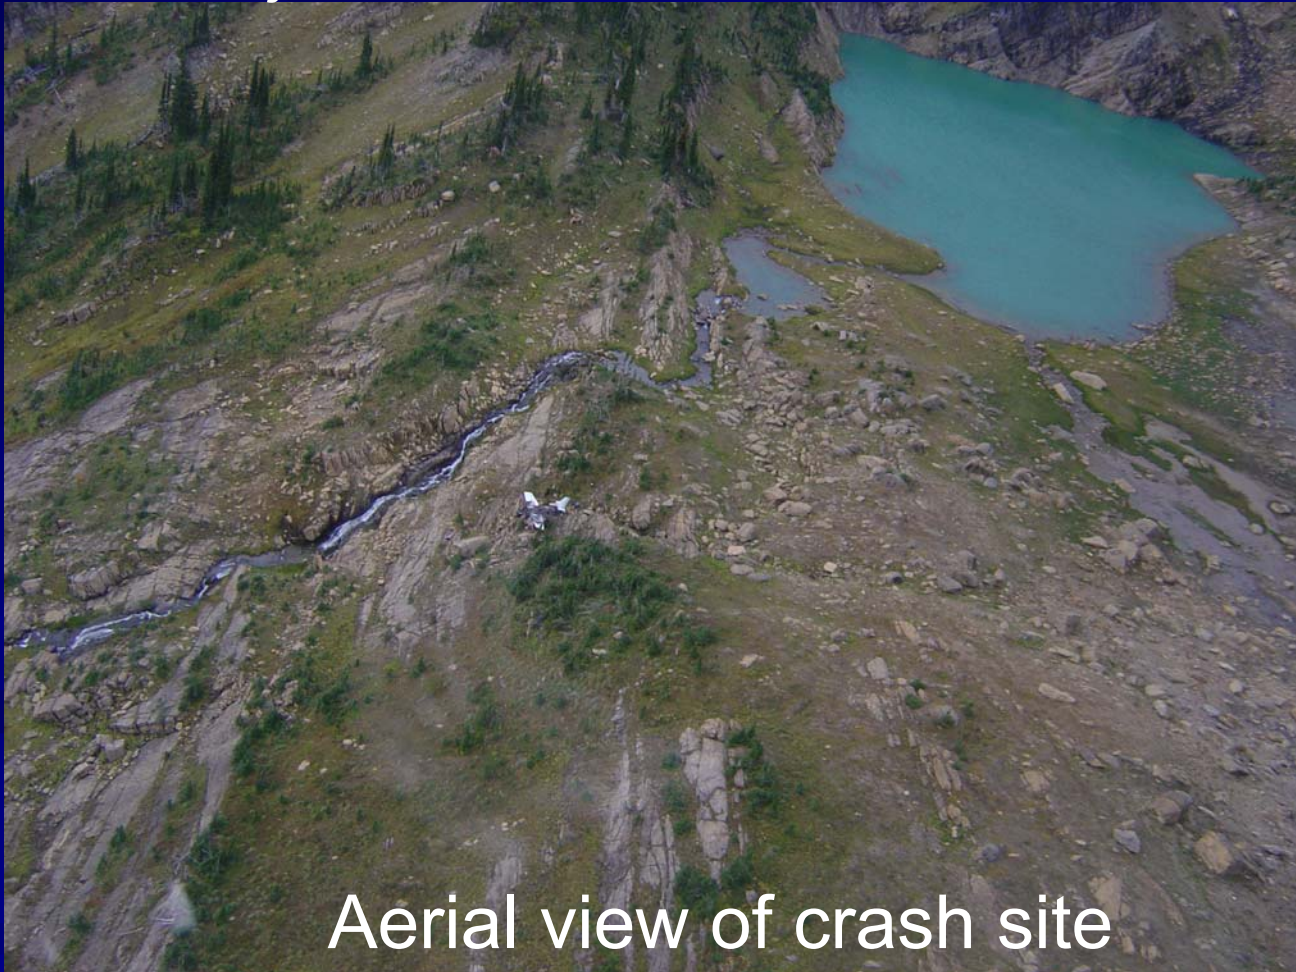
Aerial view of crash site

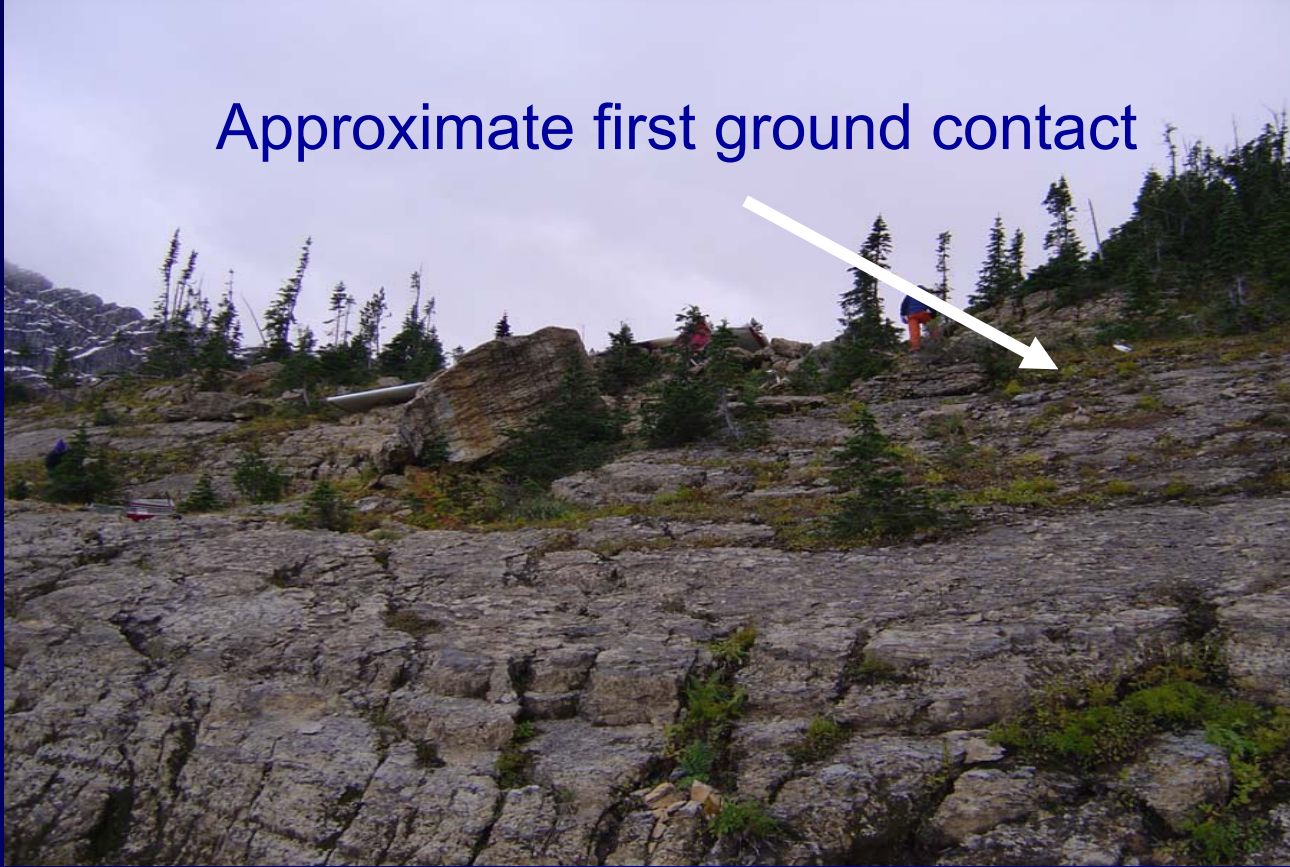
Approximate first ground contact

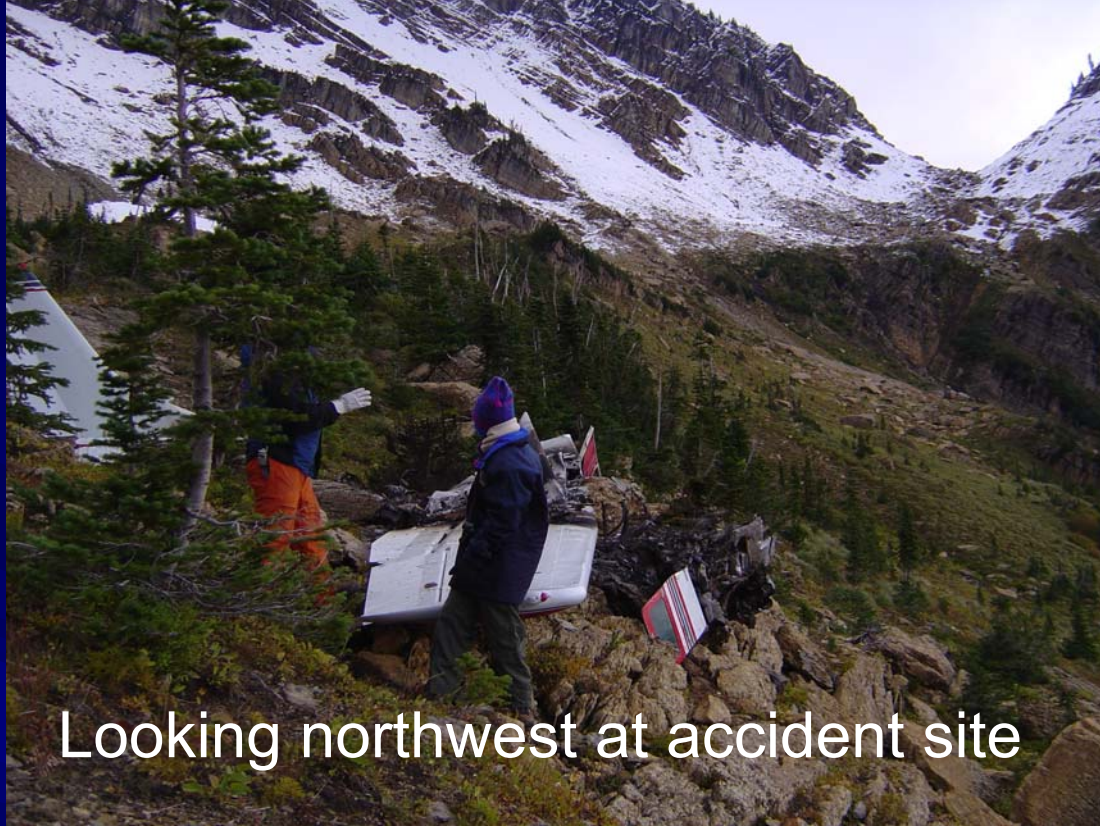
Looking northwest at accident site

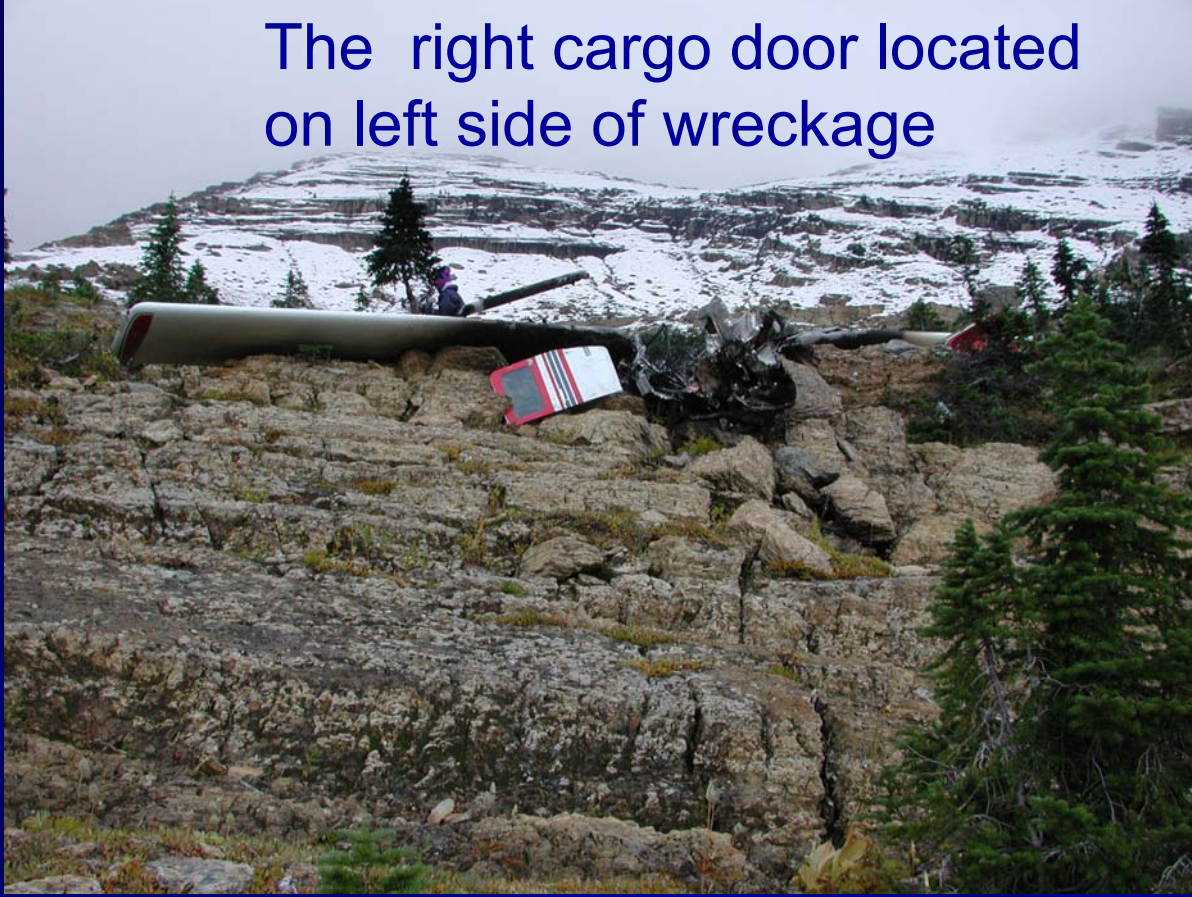
The right cargo door located
on left side of wreckage

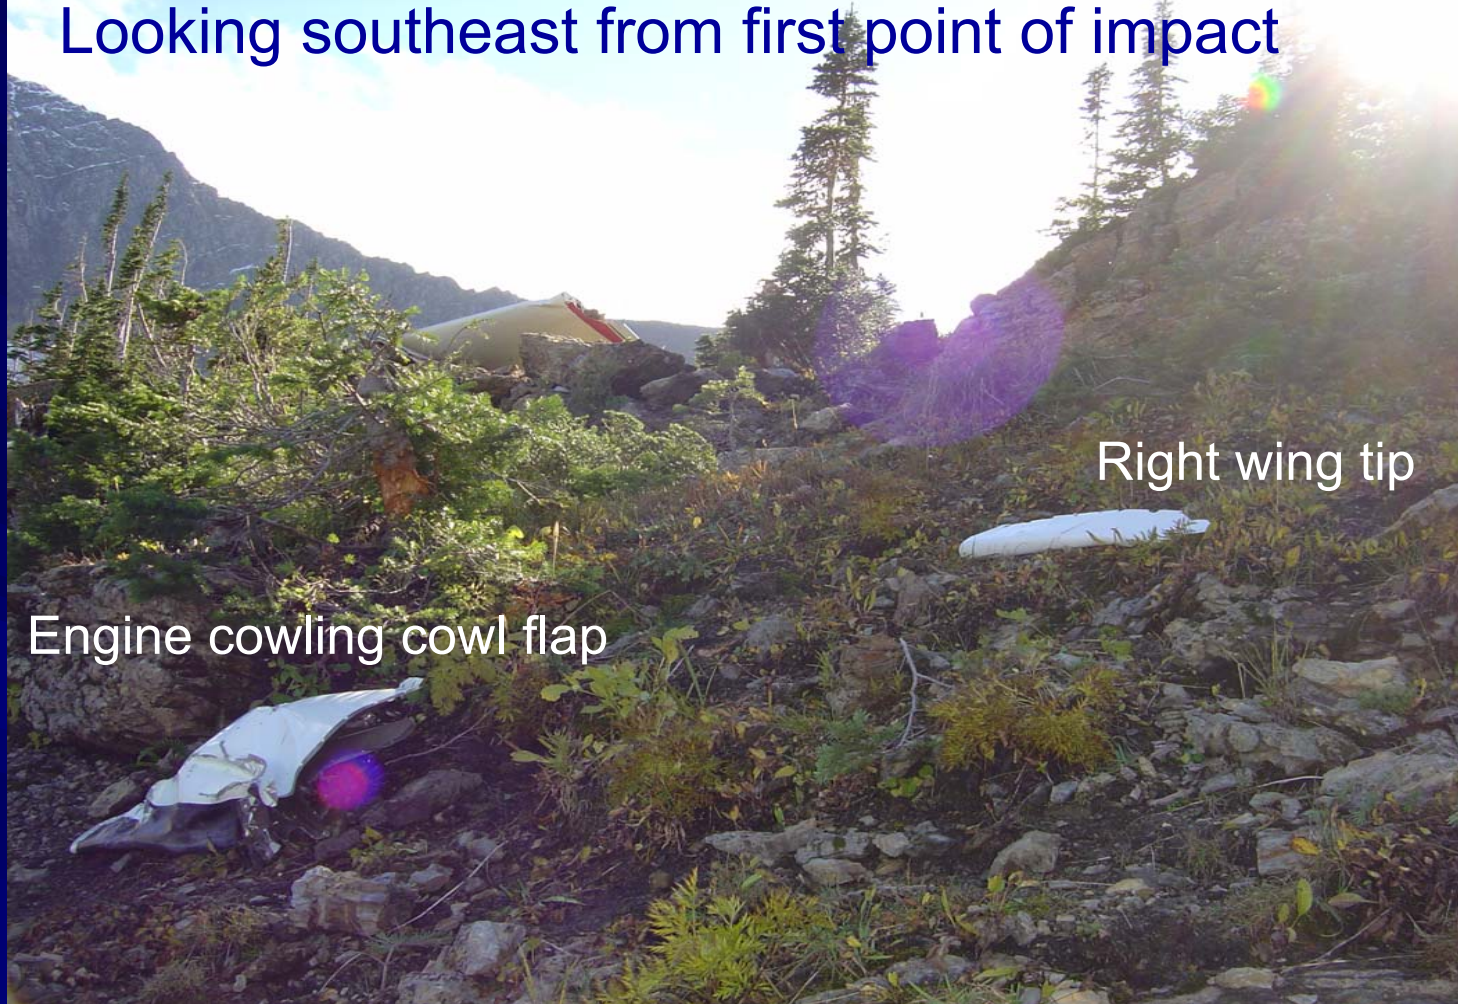
Looking southeast from first point of impact

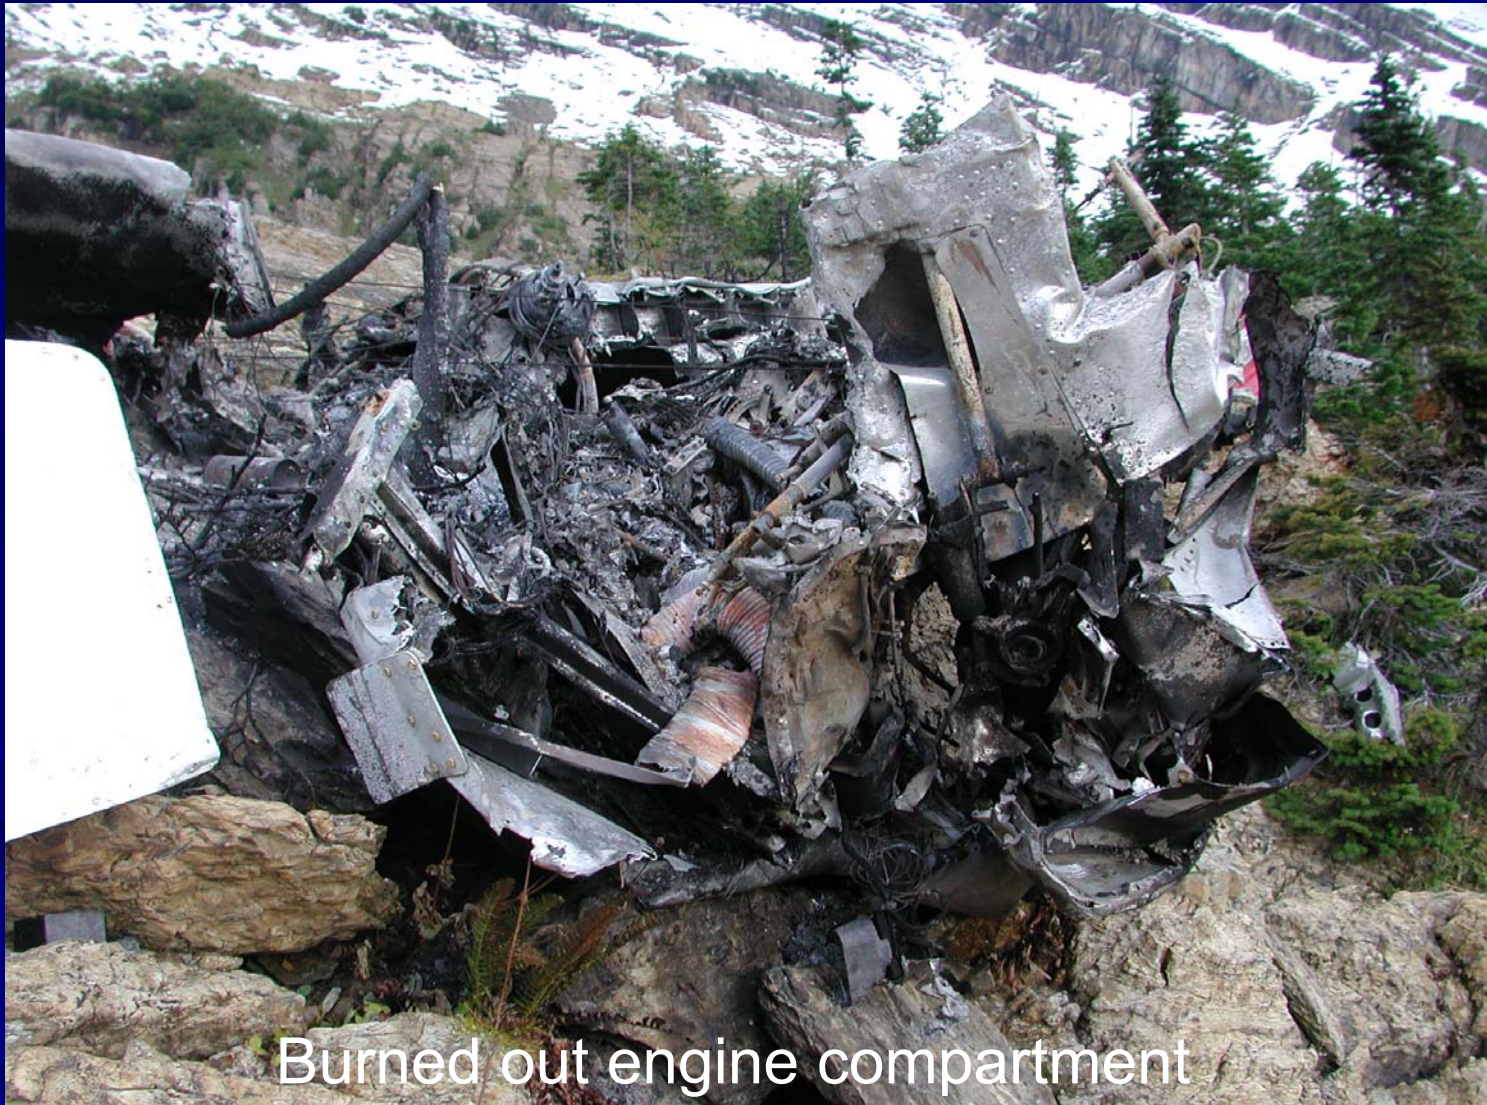
Burned out engine compartment
